This article supersedes TSB 05-4-19 to update the description for labor operation F.

ISSUE

Vehicles equipped with the parking aid reverse sensing system (RSS) may sound a warning tone when the vehicle is in reverse, even though there are no objects behind the vehicle. This condition may also occur on vehicles equipped with the forward sensing system (FSS) when vehicle is in reverse or drive.

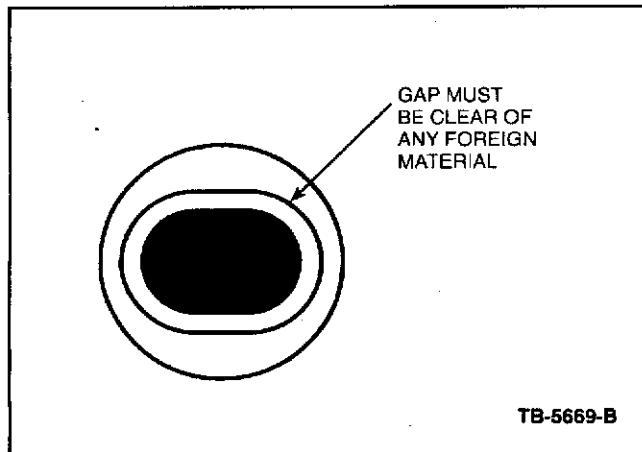
Figure 1 - Article 05-6-4

Proximity sensor surfaces may be covered with snow, ice, dirt or mud. There is a gap between the sensor membrane and its plastic housing that must remain clear (Figure 1). If this space is contaminated with any foreign material the system may sound a continuous tone or intermittent tone. The sensor surface can be cleaned by a high pressure water spray.

1. Ensure that nothing is in detectable sensor-range 6' (1.8 meters) behind vehicle for the RSS and within 6' (1.8 meters) of the front of the vehicle for the FSS.
2. Clean proximity sensors with a dry shop towel, and if required wash with water or a high pressure water to ensure that the membrane gap is free of any dirt or contamination.
3. Using the New Generation Star (NGS) tester (up to 2004 MY), NGS+ (2005 MY) or WDS observe the following four parking aid module parameter identification displays (PIDs) for distance information:
 - LR_CNTD (NGS)/LRI_DIST (WDS): (Left Rear Center Sensor Distance To Obstacle)
 - RR_CNTD (NGS)/RRI_DIST (WDS): (Right Rear Center Sensor Distance To Obstacle)
 - LR_CNRD (NGS)/LRO_DIST (WDS): (Left Rear Corner Sensor Distance To Obstacle)
 - RR_CNRD (NGS)/RRO_DIST (WDS): (Right Rear Corner Sensor Distance To Obstacle)
